**CALSPAN ON-SITE AIR BAG DEPLOYMENT INVESTIGATION**

**CALSPAN CASE NO. 95-20**

**VEHICLE #1 - 1994 CHEVROLET CAMARO Z28 CONVERTIBLE  
(DUAL AIR BAG-EQUIPPED)**

**LOCATION - UTAH**

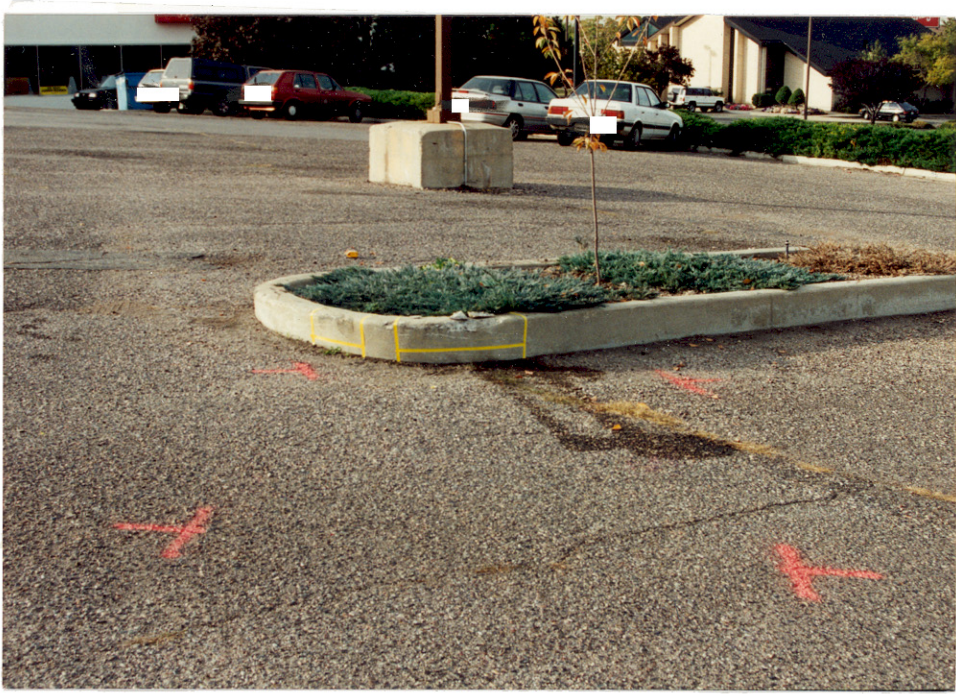
13. Trajectory of Vehicle #1 showing the POI with the parking lot island curb.

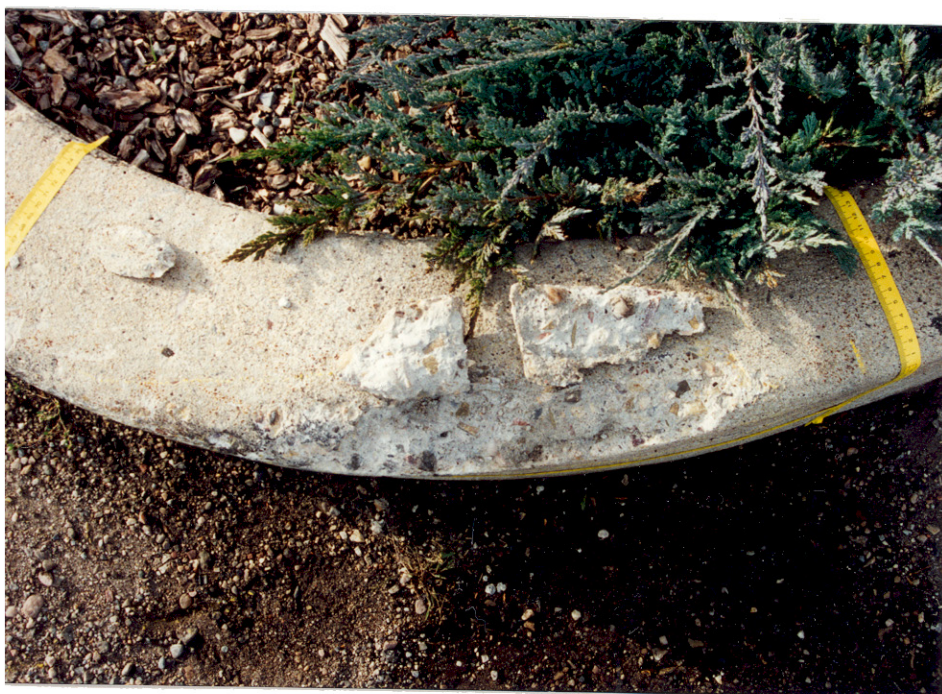
18. Overhead close-up view of the undercarriage contact with the curb showing concrete fragments separated during the crash.

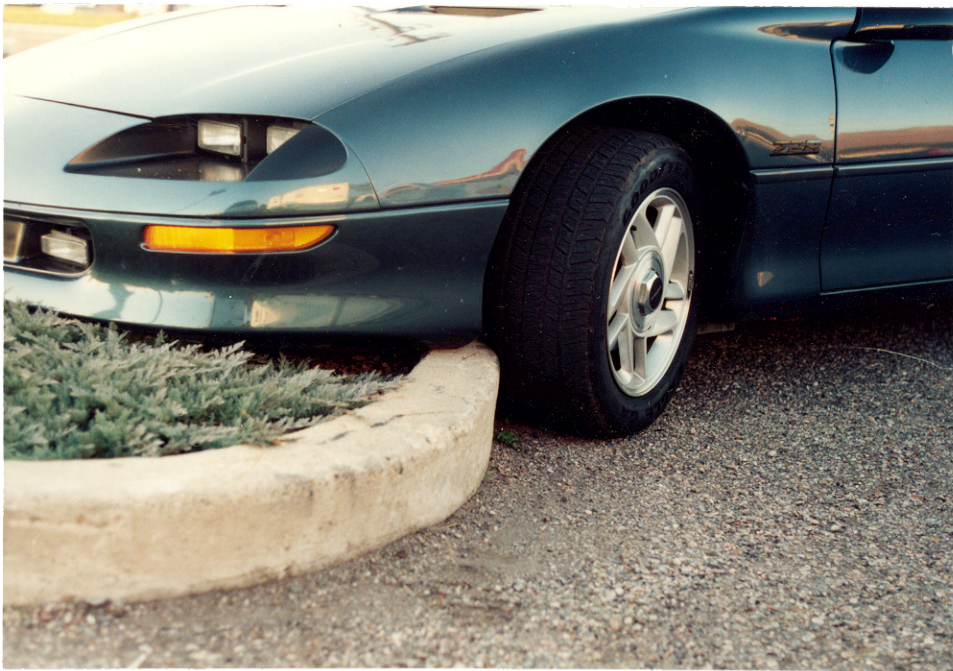
21. On-scene police photograph of the left front corner of Vehicle #1 at the FRP.

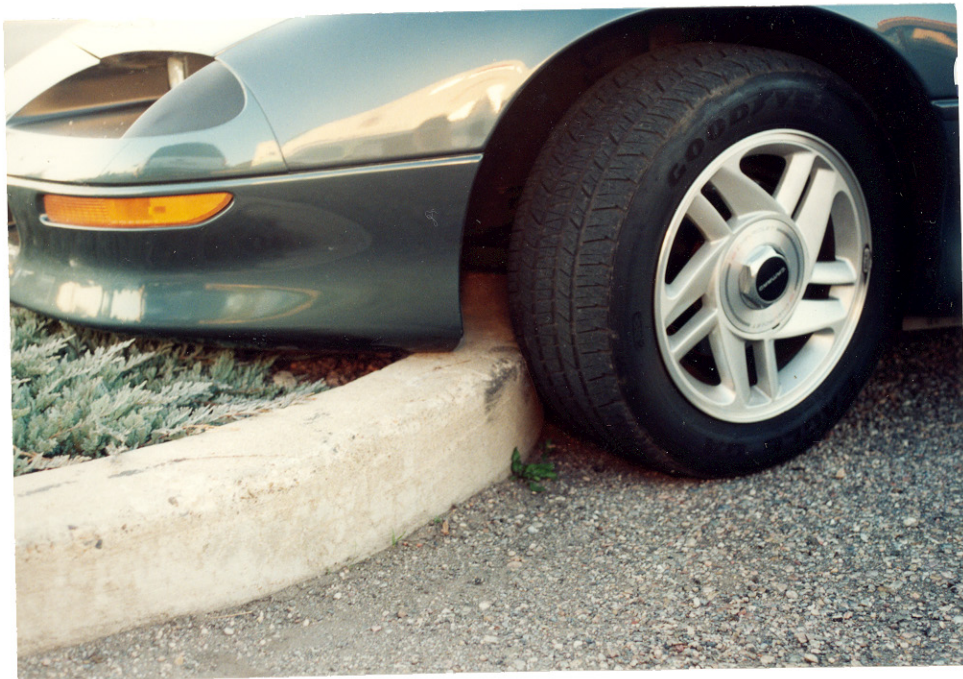
The engine cradle was displaced rearward 12.7 mm (0.5") as the result of the contact sequence. The left front tire contacted the curb as noted in the scene photographs and subsequently rebounded slightly as noted in on-scene photograph #22 on page A-11.

22. On-scene police close-up photograph of the left front corner of Vehicle #1 at the FRP.

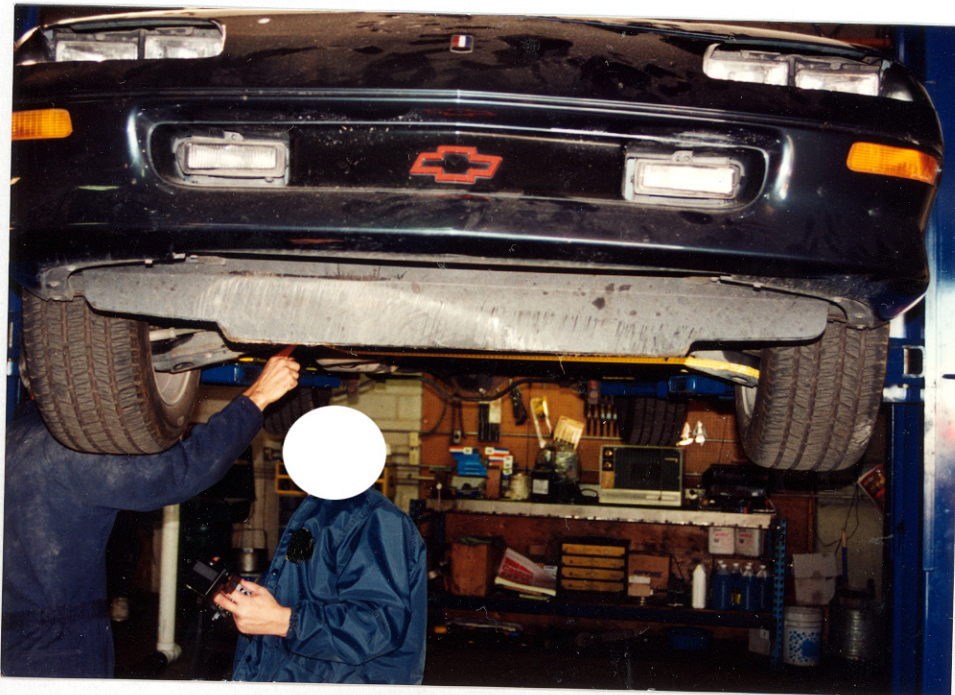
47. View of the front air dam showing curb impact gouges .

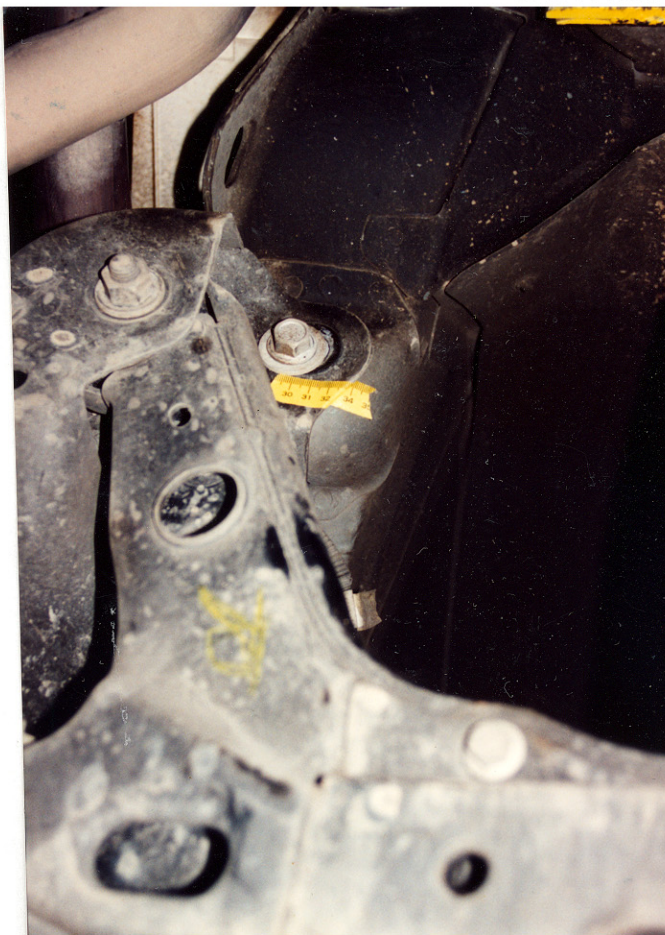
54. View of the 12.7 mm (0.5") rearward movement of the engine cradle as measured at the left rear engine cradle bolt.

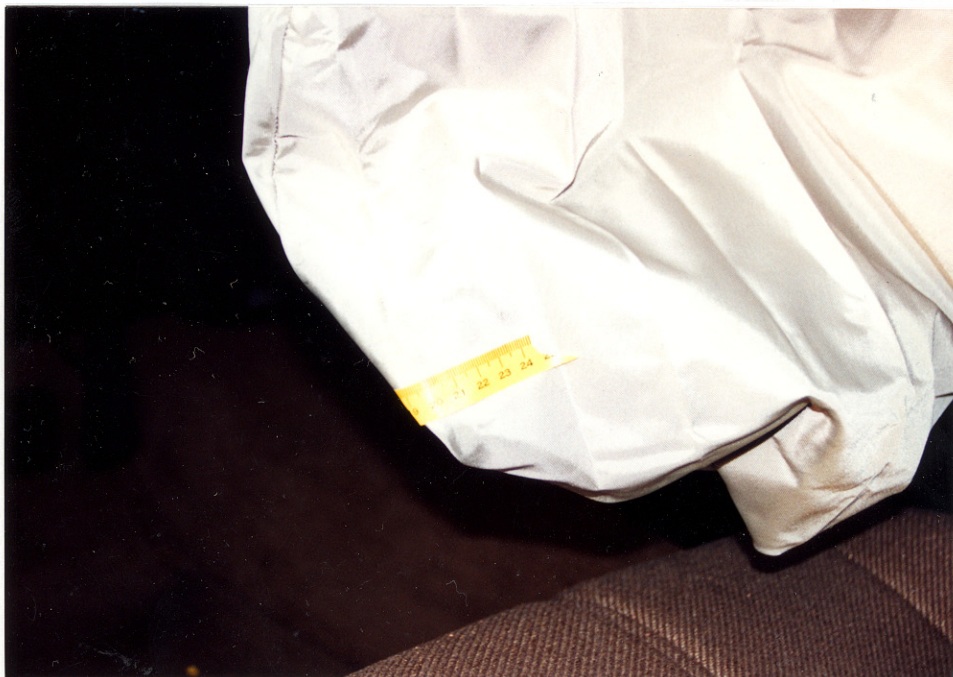
72. View of a pink/reddish transfer mark located near the bottom area of the driver air bag.

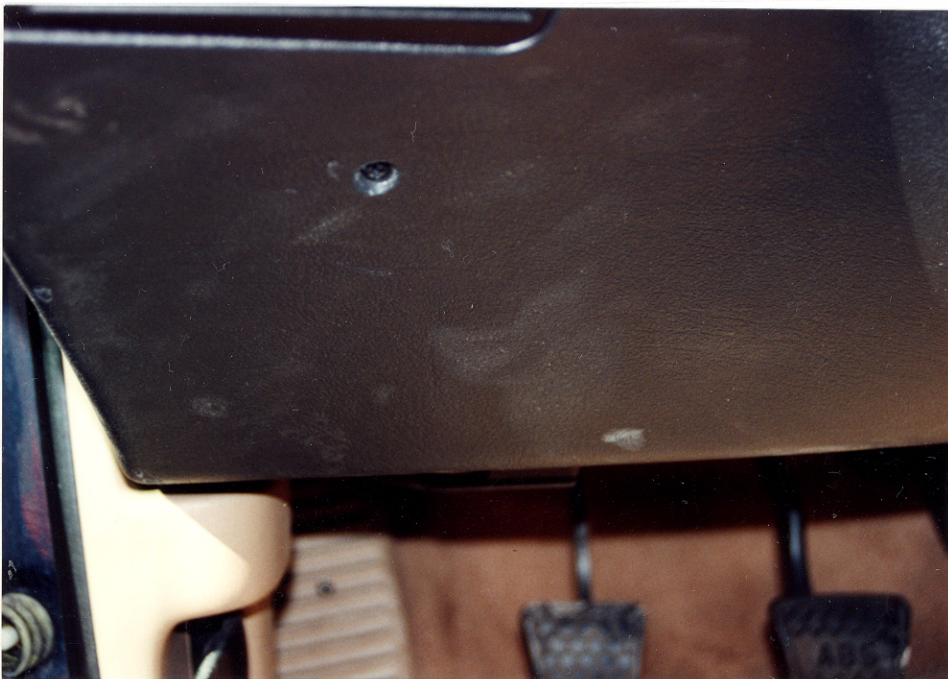
The driver was also not restrained by the restraint belt as noted in this report. She, however, made adamant statements to the contrary that she was wearing her restraint belt at the time of the crash. Injury data (contusions on the right side of her face and neck), scuff marks on the knee bolster, and the data contained in the EEPROM do not support her statements.

74. Contact evidence on the left side of the driver side knee bolster.

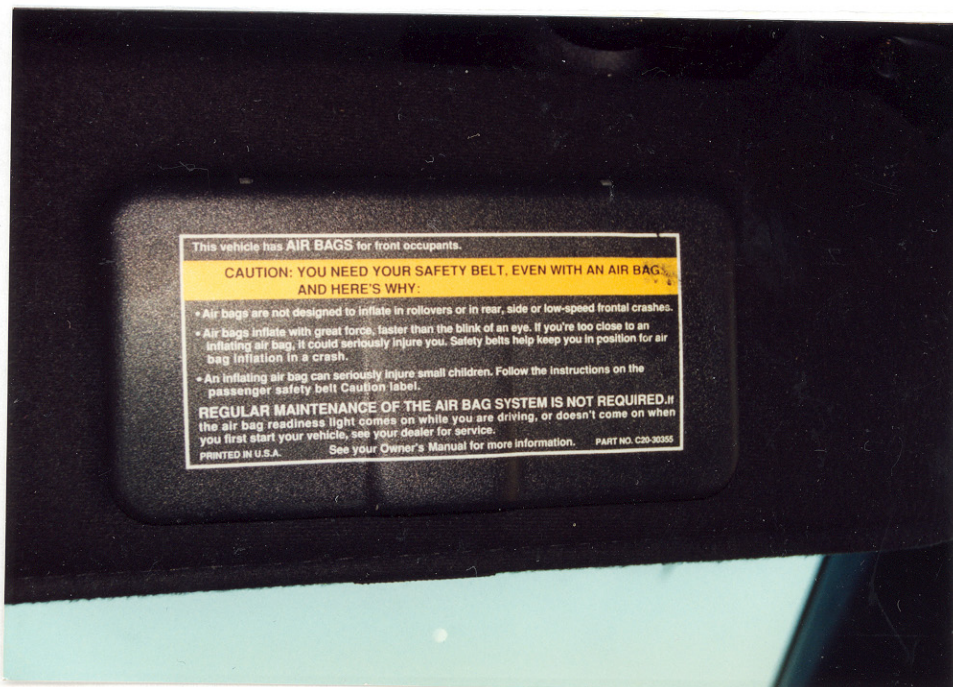
The head/face contact resulted in tissue transfer to both the glazing and the fabric overlying the windshield header. Samples taken by the state crime laboratory verified these transfers as skin and hair. The right side of the skull sustained numerous, delicate, red linear hyperemic lines and slight distortion/wrinkling of the external surface of the skull. The coronal suture line was fractured and the brain sustained a subarachnoid hemorrhage, subdural hemorrhage, and numerous hemorrhages of the cortex which were consistent with striking a hard surface.

85. Close-up view of the windshield and windshield header contact points.

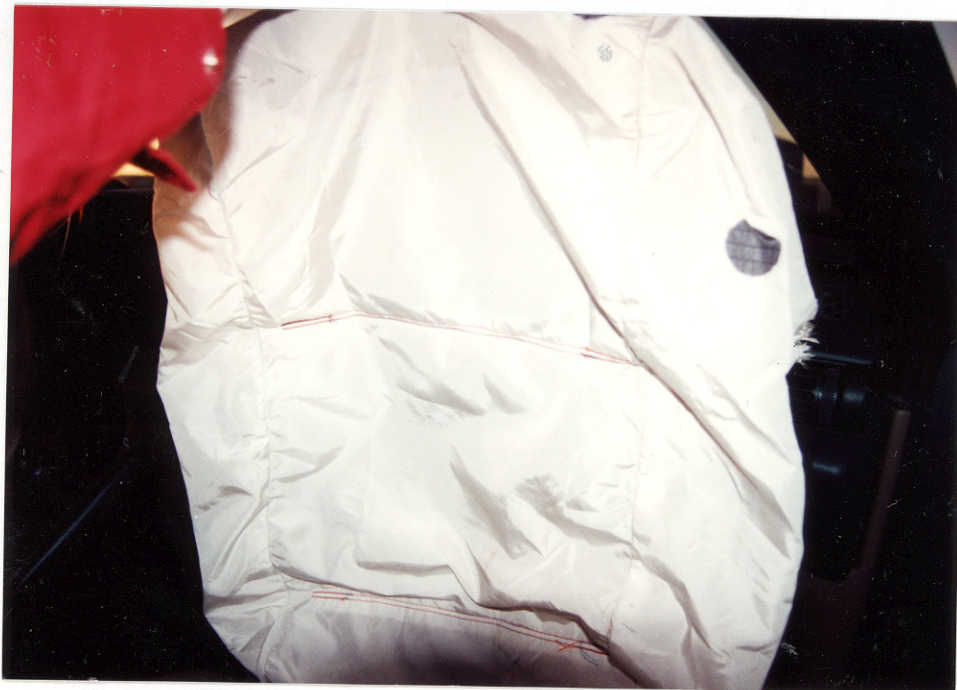
90. Overall view of the passenger side air bag.

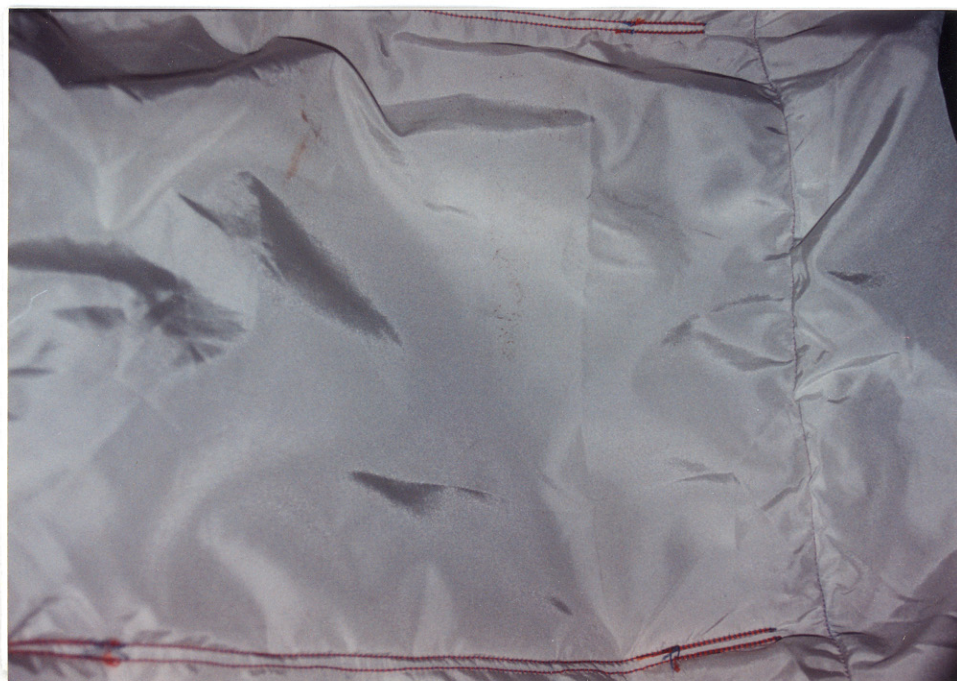
As the air bag deployed, the double stitching of the upper tether contacted the left side of his head and face (refer to photograph #102-#103 on pages A-53, A-54) resulting in a distinctive parallel contusion pattern. As the air bag continued to unfurl, the fabric of the air bag raked across the left side of the face. This was apparent from the extensive confluent abrasion pattern noted in the medical examiner's report.

91. Closer view of the passenger side air bag showing the upper and lower tether attachment points which can be seen by the two double lateral red stitch rows. These rows measured 33.66 cm (13.25") in length and were 30.5 cm (12.0") apart.

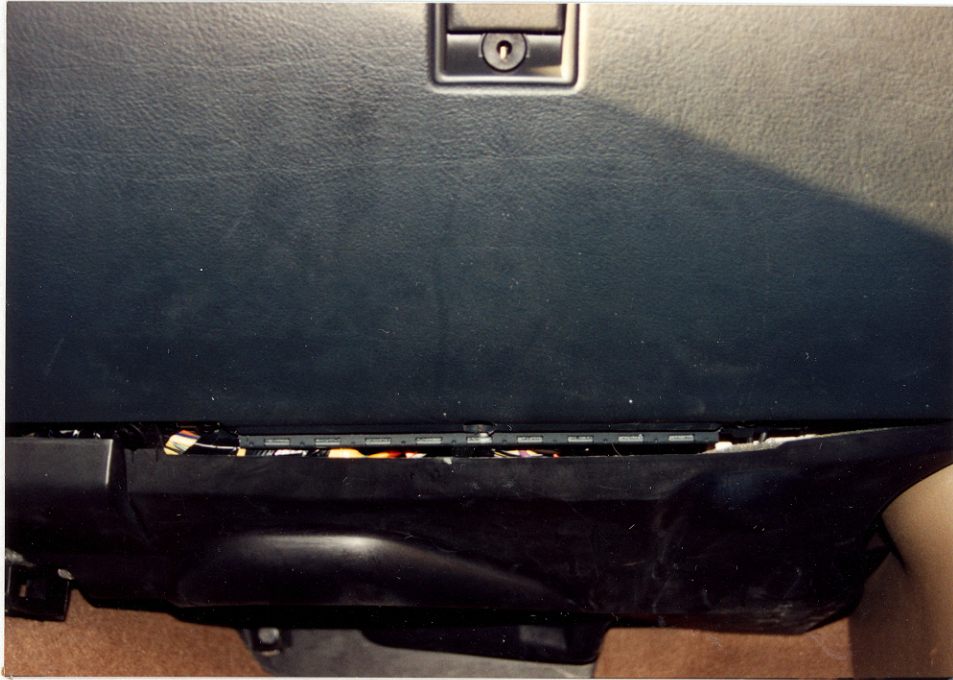
95. View of the glove compartment door and the hush panel (i.e., horizontal panel under the glove compartment).

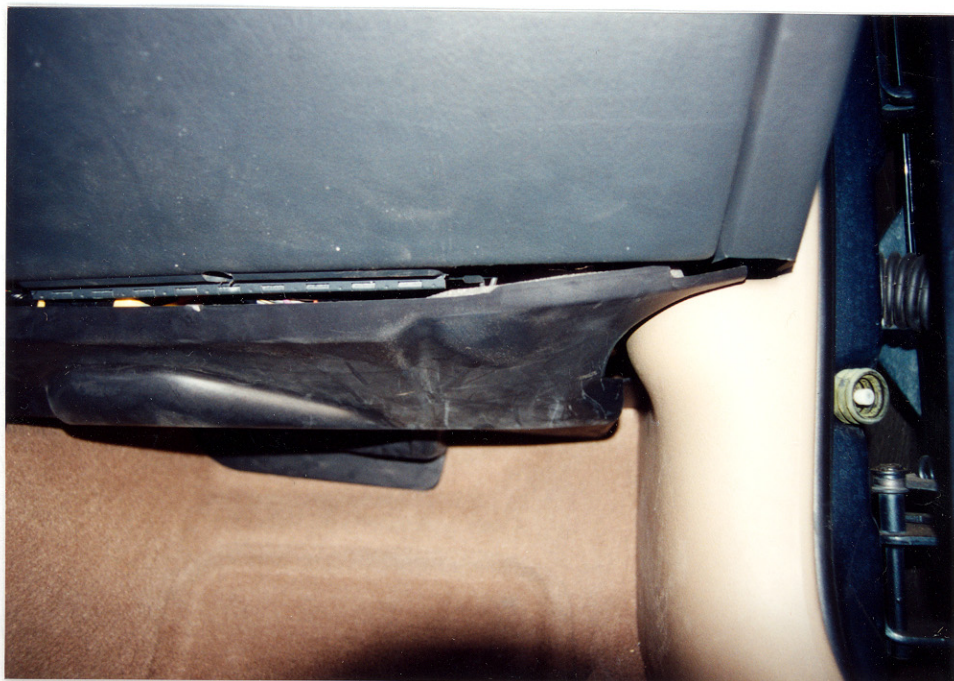
96. Closer view of the right side of the hush panel showing a cloth transfer mark.

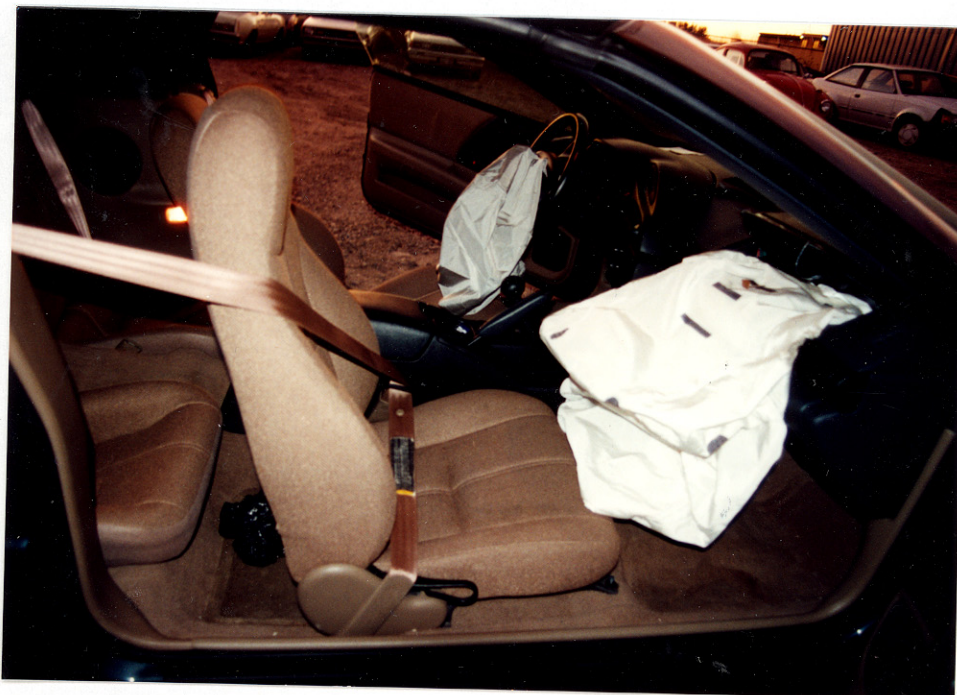
97. Lateral view of the right front seat with the restraint belt attached and the air bag unfurrowed.

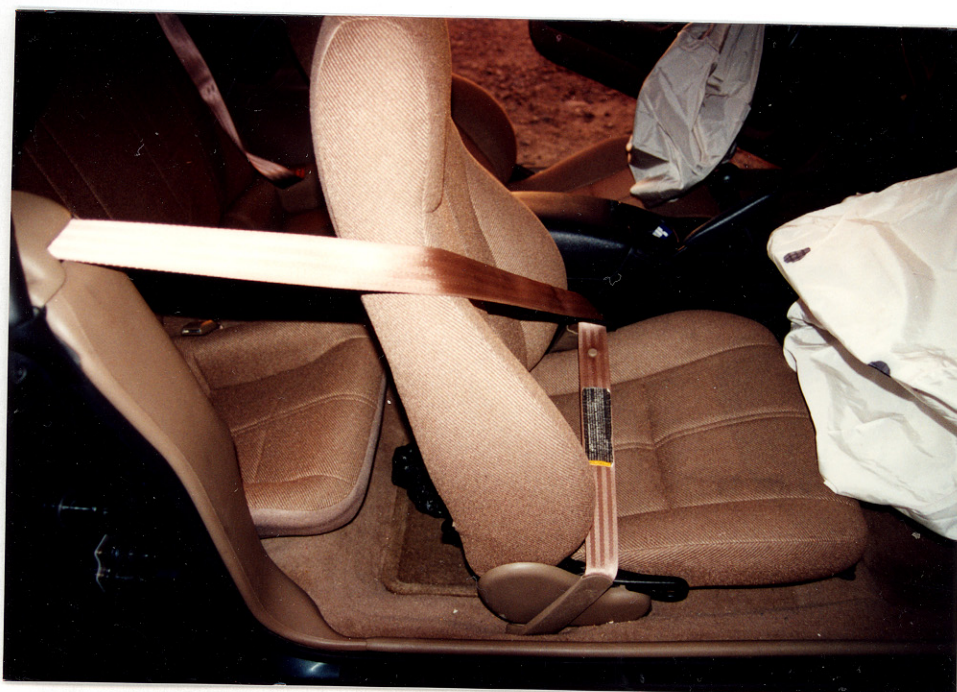
98. A closer view of the right front seat.

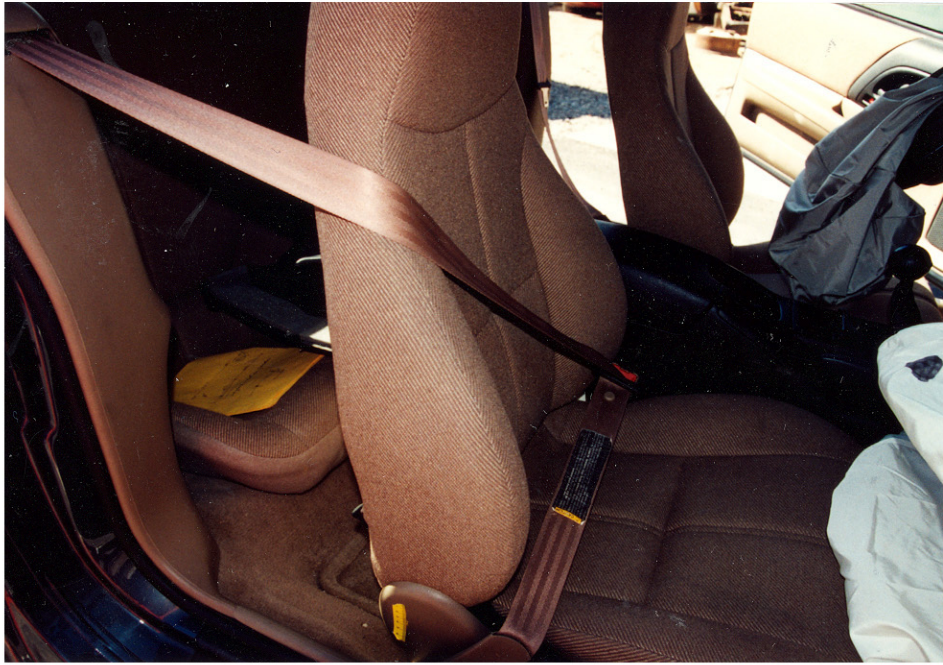
99. Rearward facing angular view of the right front seat.

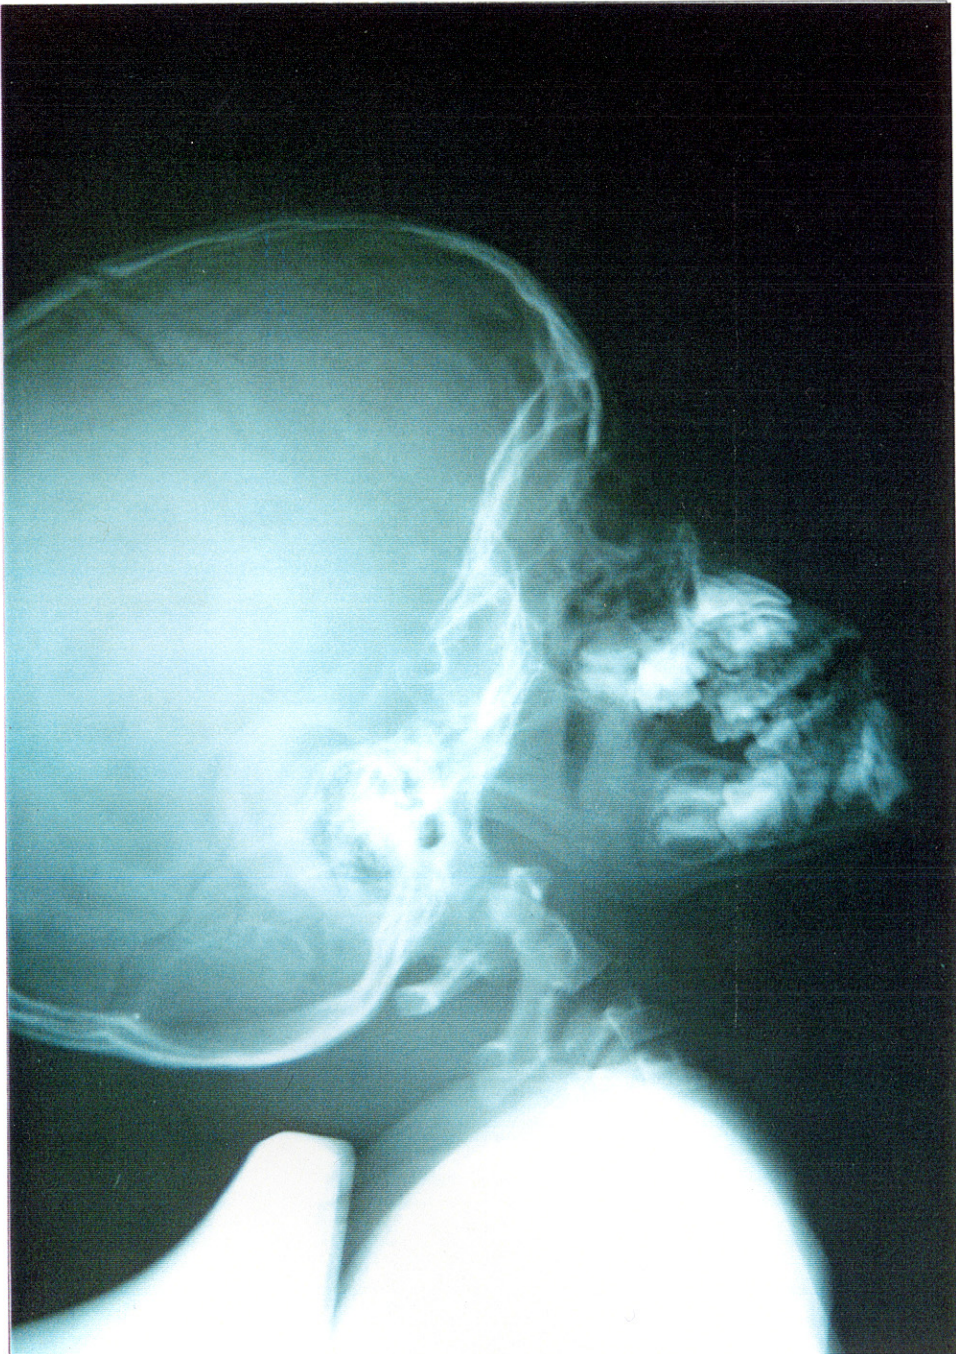
115. X-ray view taken from the right side of the cervical vertebrae with the neck in the extension position.  
Note the rearward position of the odontoid bone into the spinal canal.
